# **REMEDIAL ACTION REPORT**

**AOC-24: Woodbridge Pond**

**HATCO CORPORATION SITE**

**November 2020**

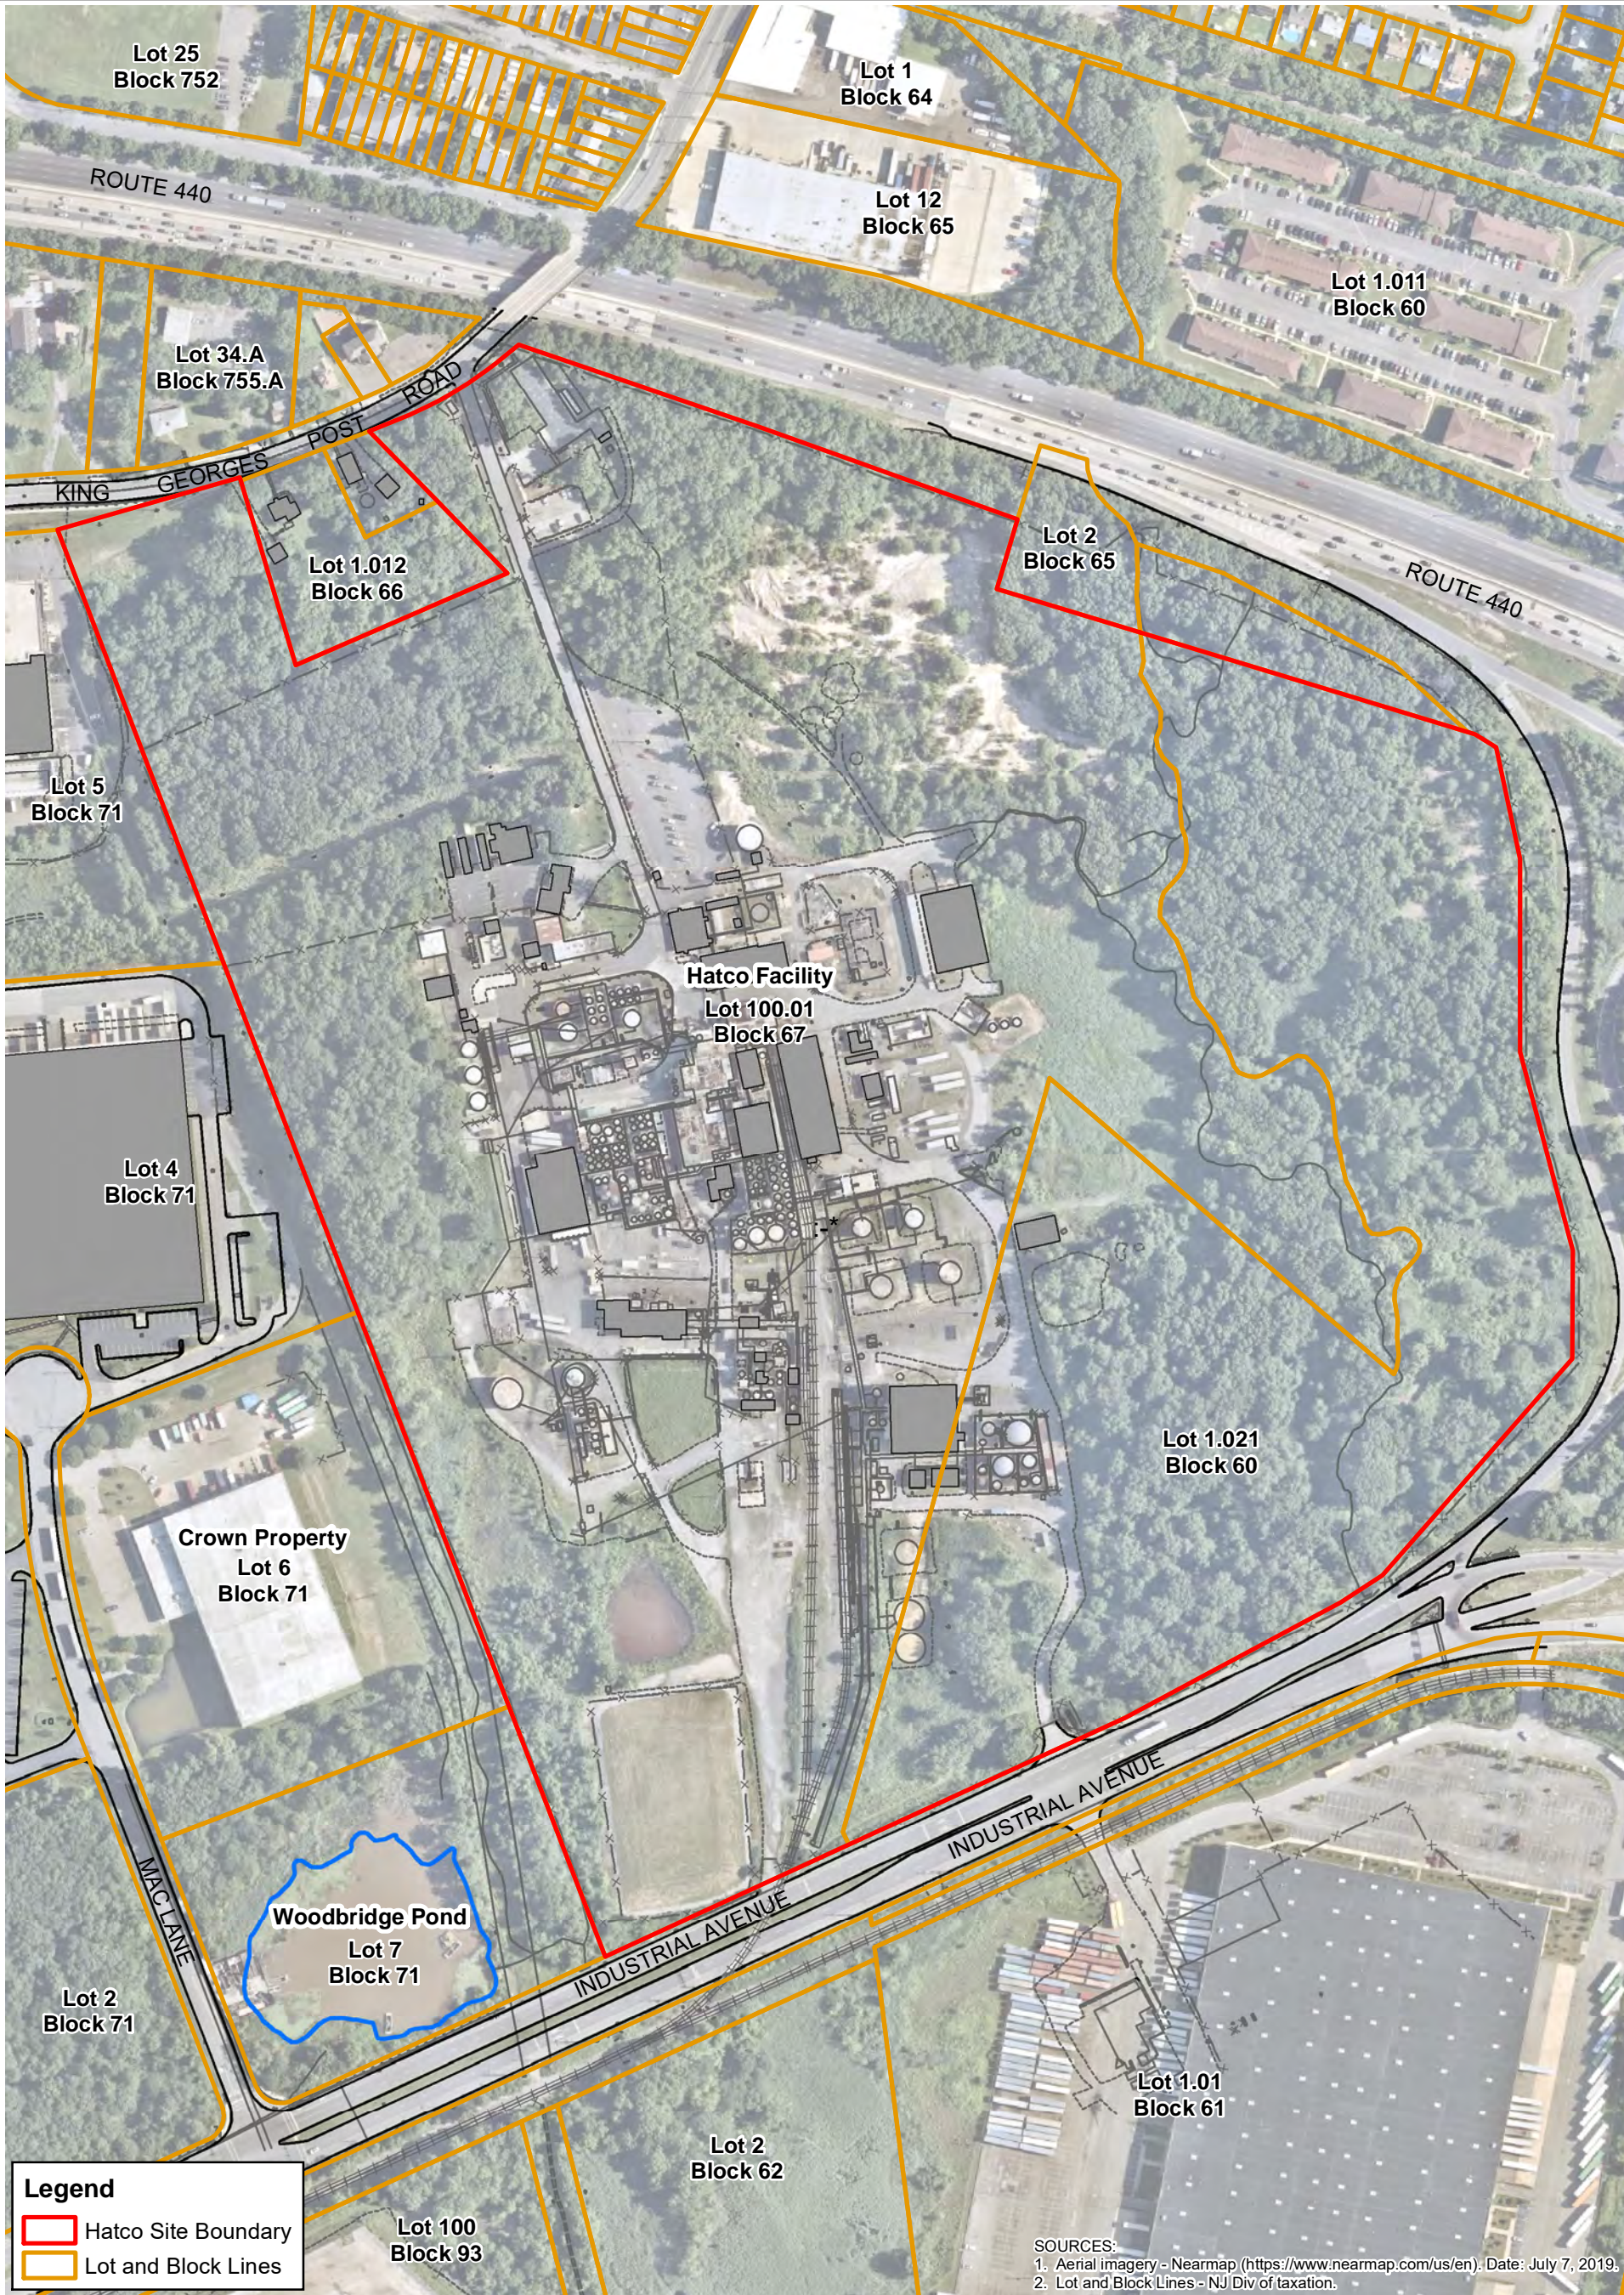
FIGURE: 1-2 SCALE: 1" = 80' DATE: 6/2/2020

DRAWING TITLE:  
SITE MAP AND  
AREAS OF CONCERN

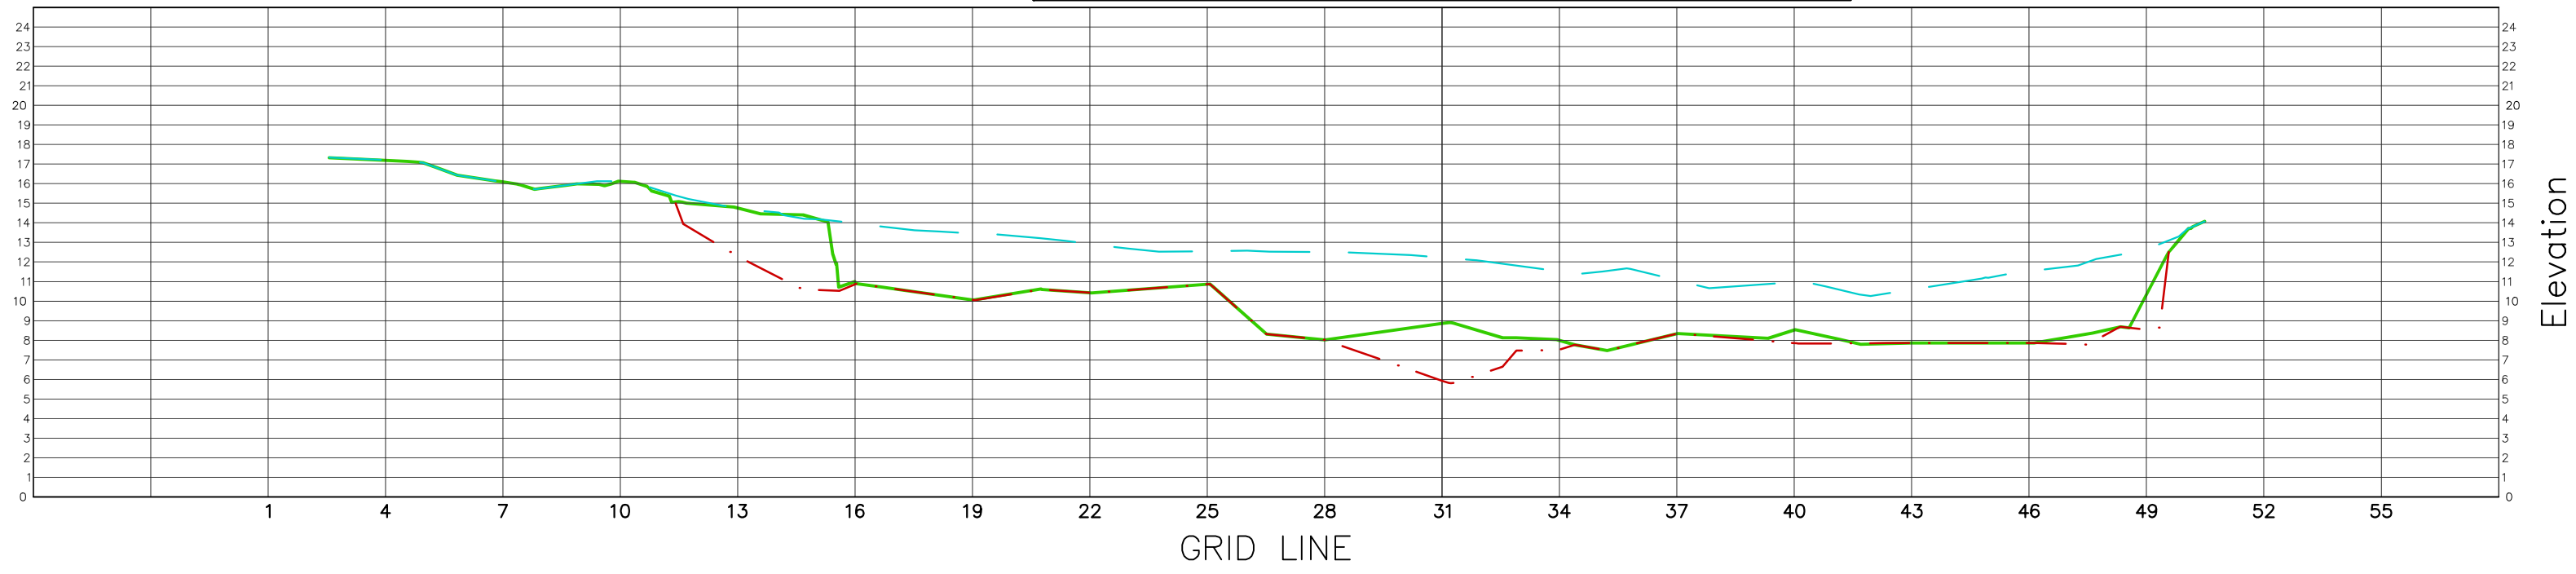
CROSS SECTION – GRID LINE BH

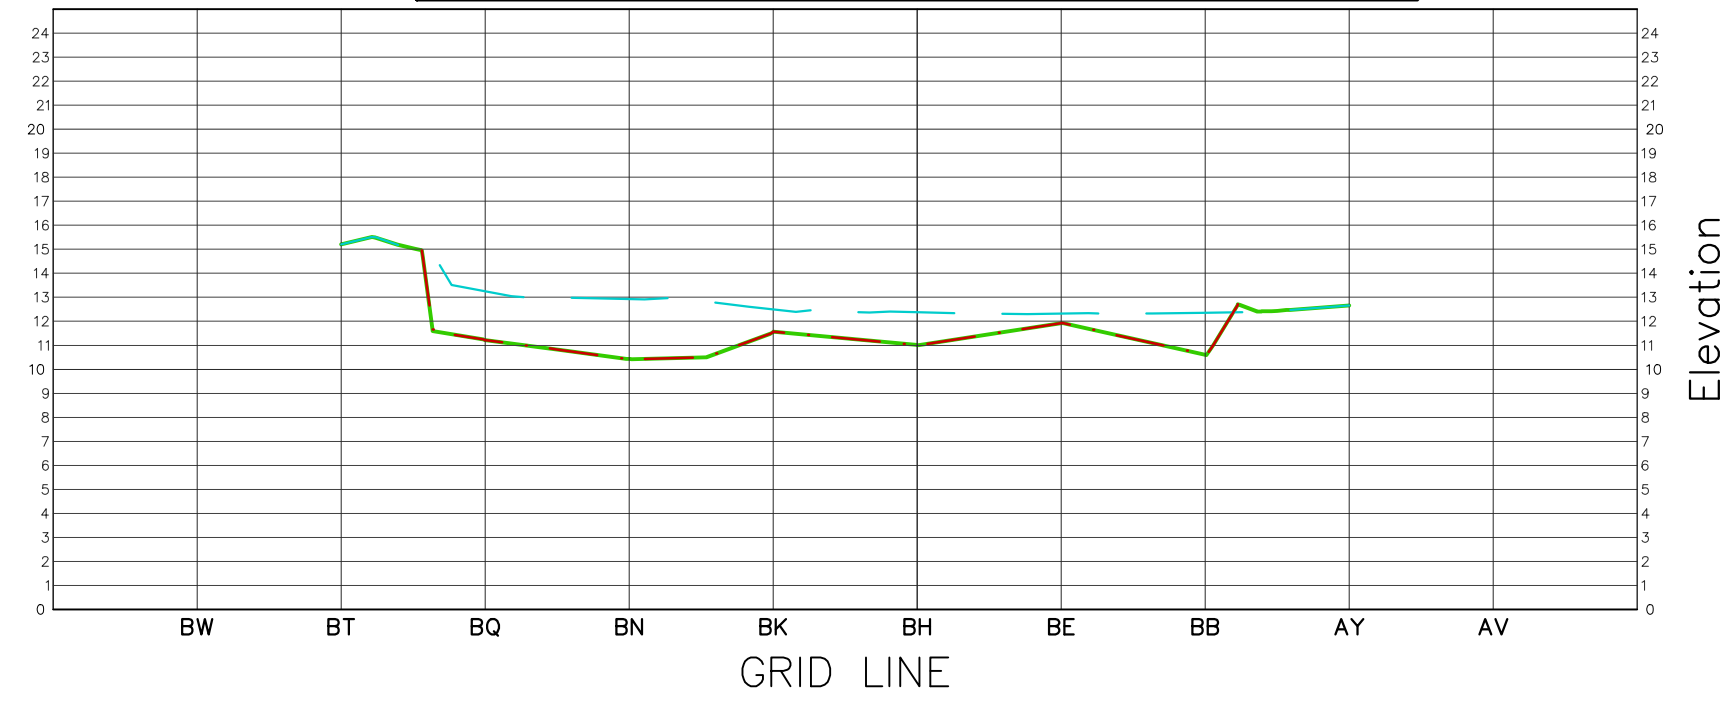
CROSS SECTION – GRID LINE 22

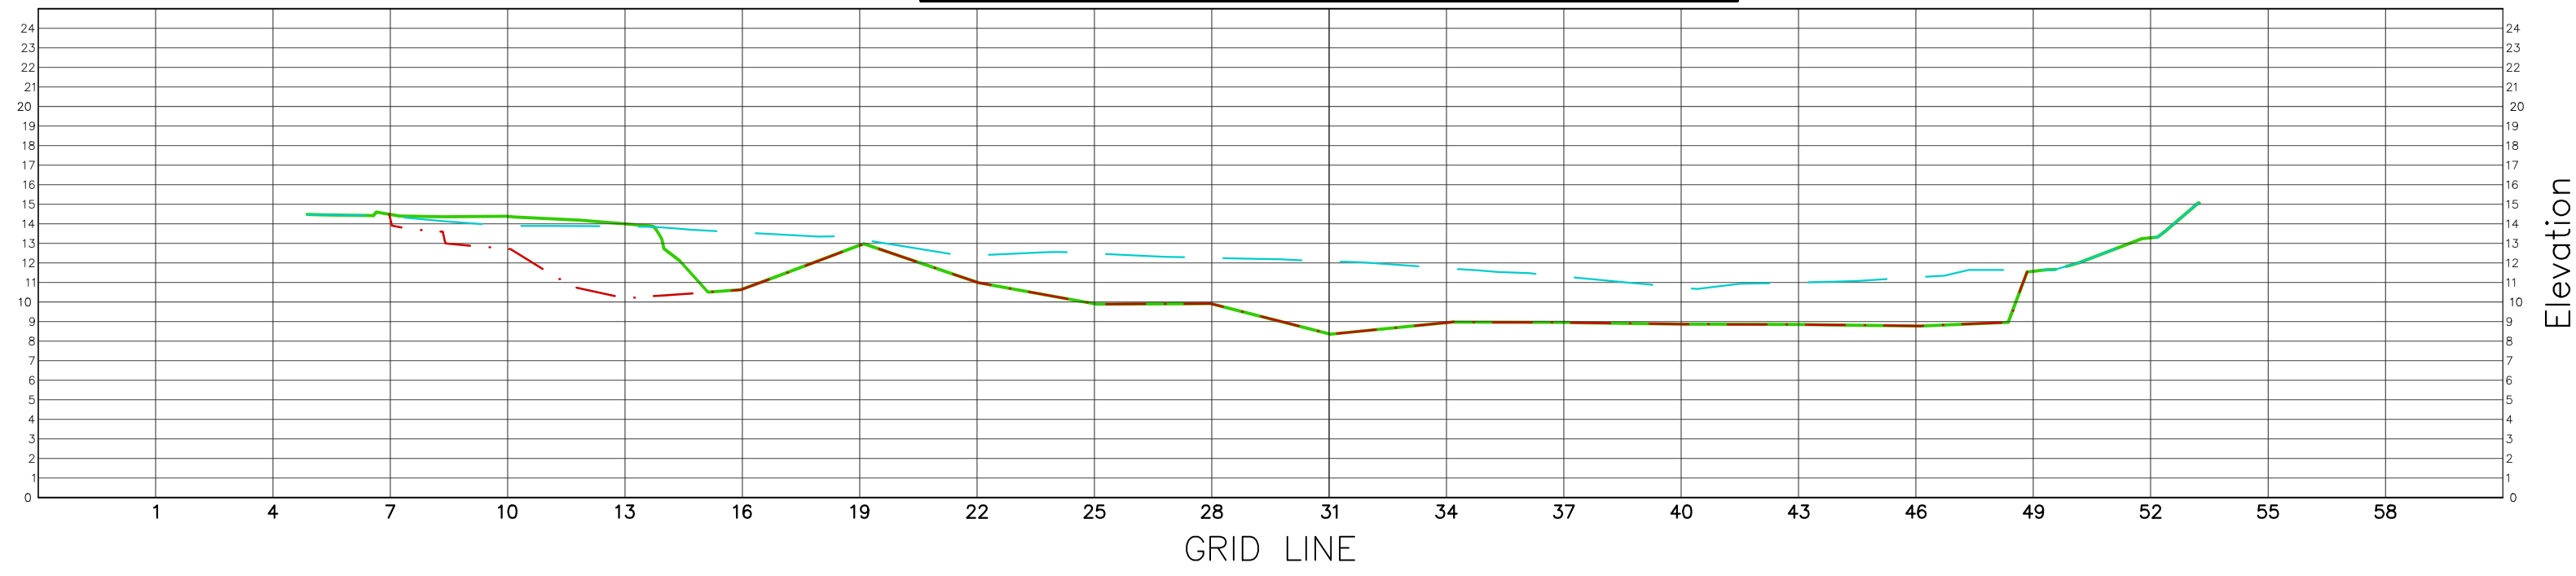
CROSS SECTION – GRID LINE BN

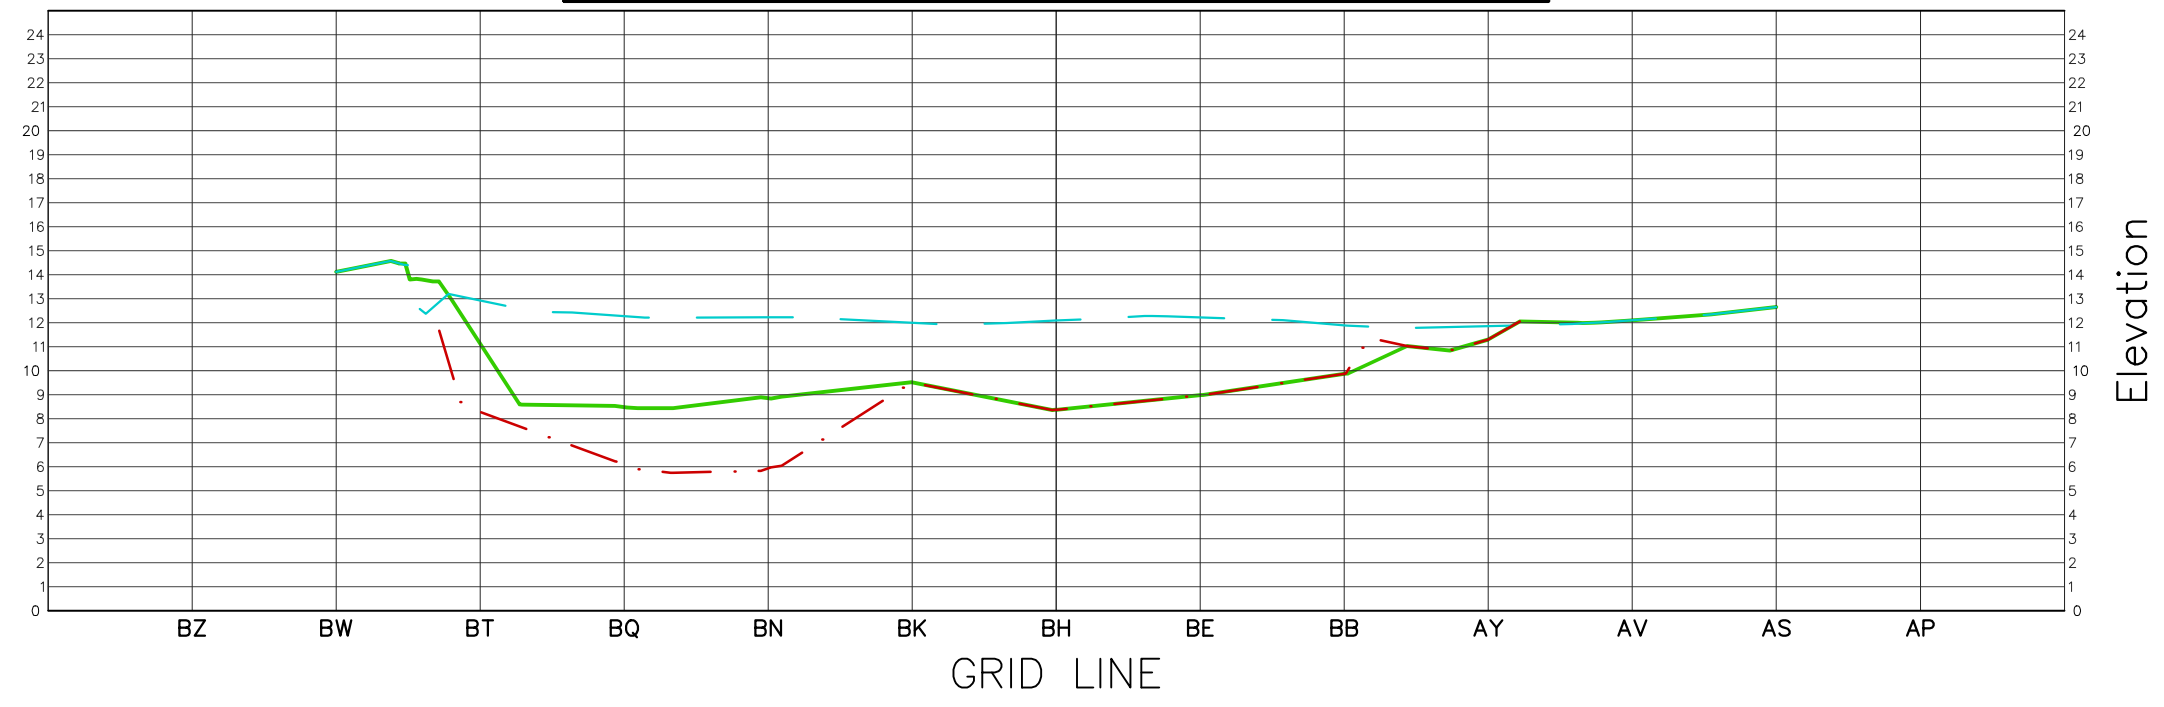
CROSS SECTION – GRID LINE 31

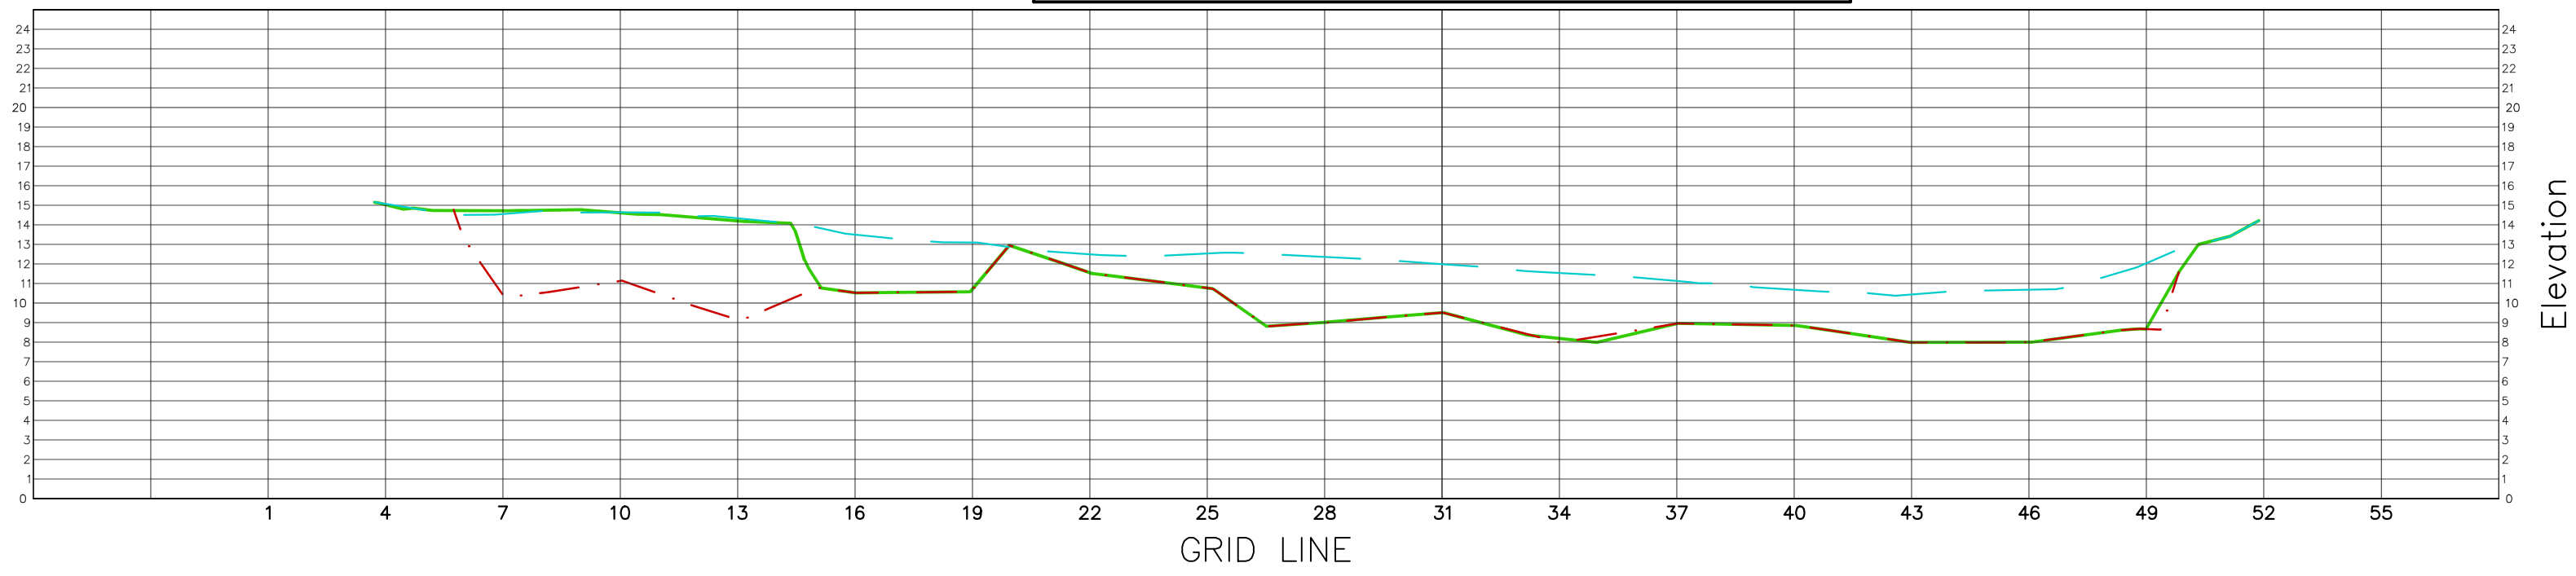
CROSS SECTION – GRID LINE BK

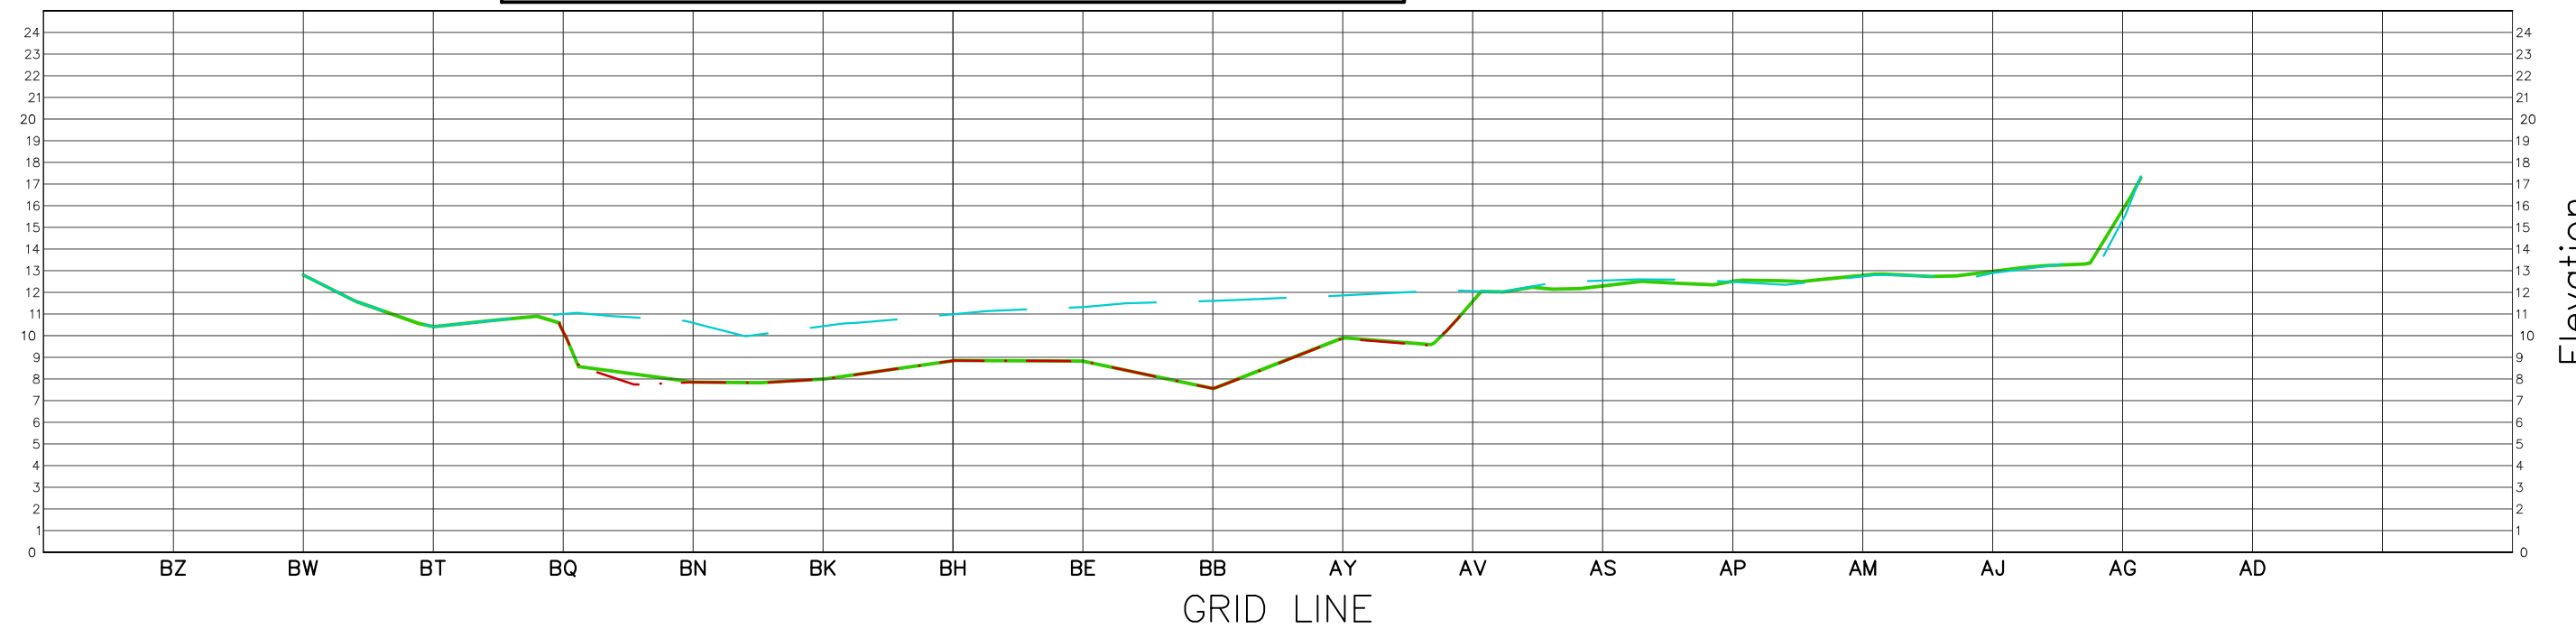
CROSS SECTION – GRID LINE 43

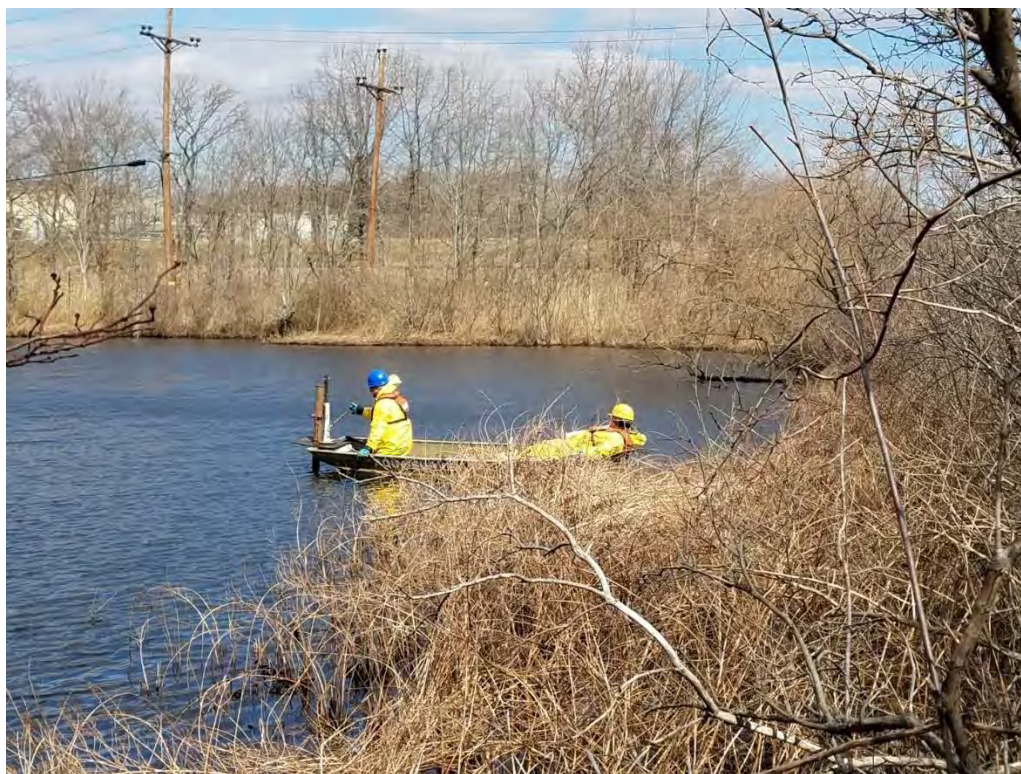
March 12, 2019. Pond bottom sampling for waste characterization

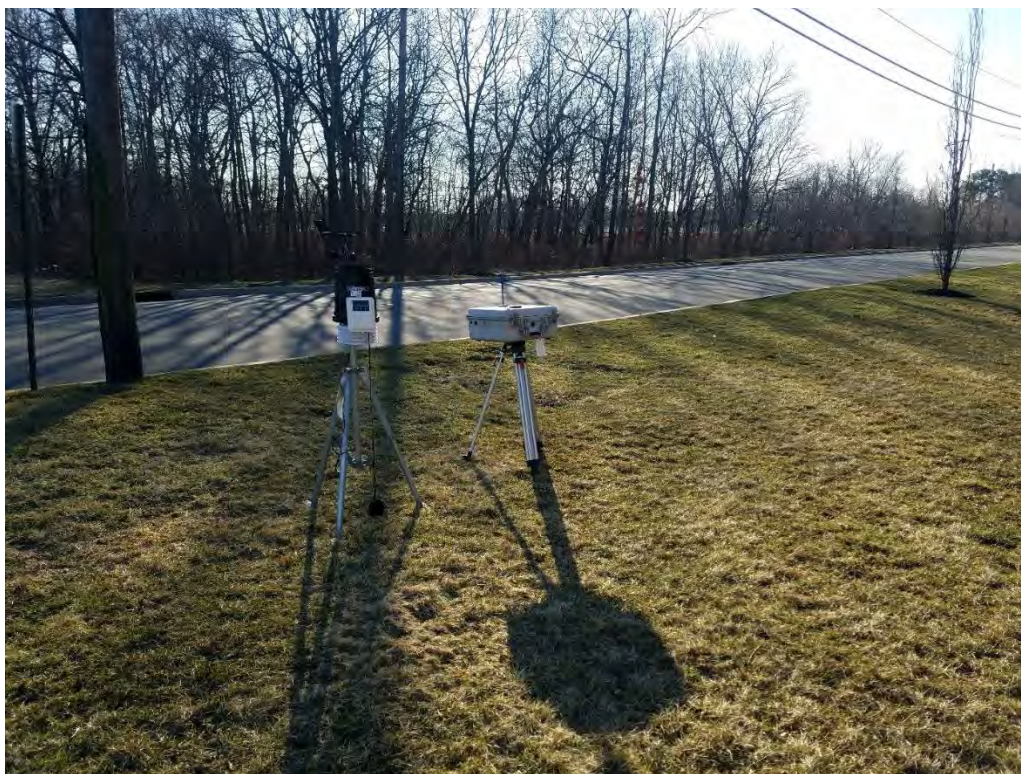
March 19, 2019. Perimeter air monitoring station during baseline sampling.

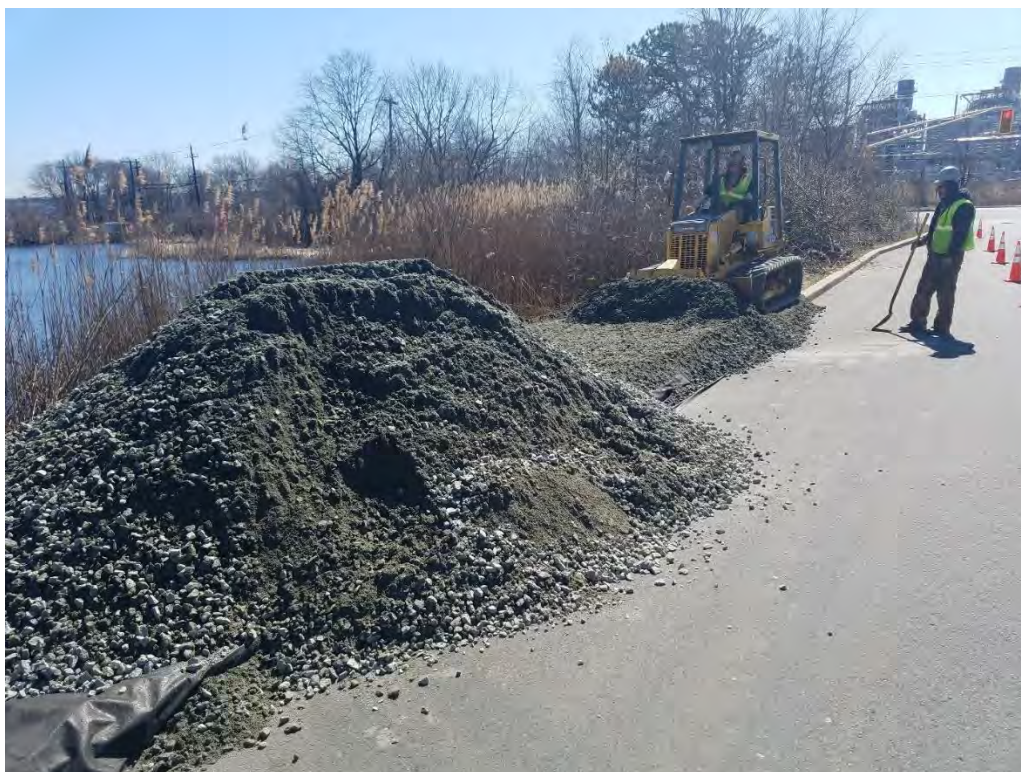
March 26, 2019. Placement of protective liner and stone at curb line for access to temporary staging and processing area

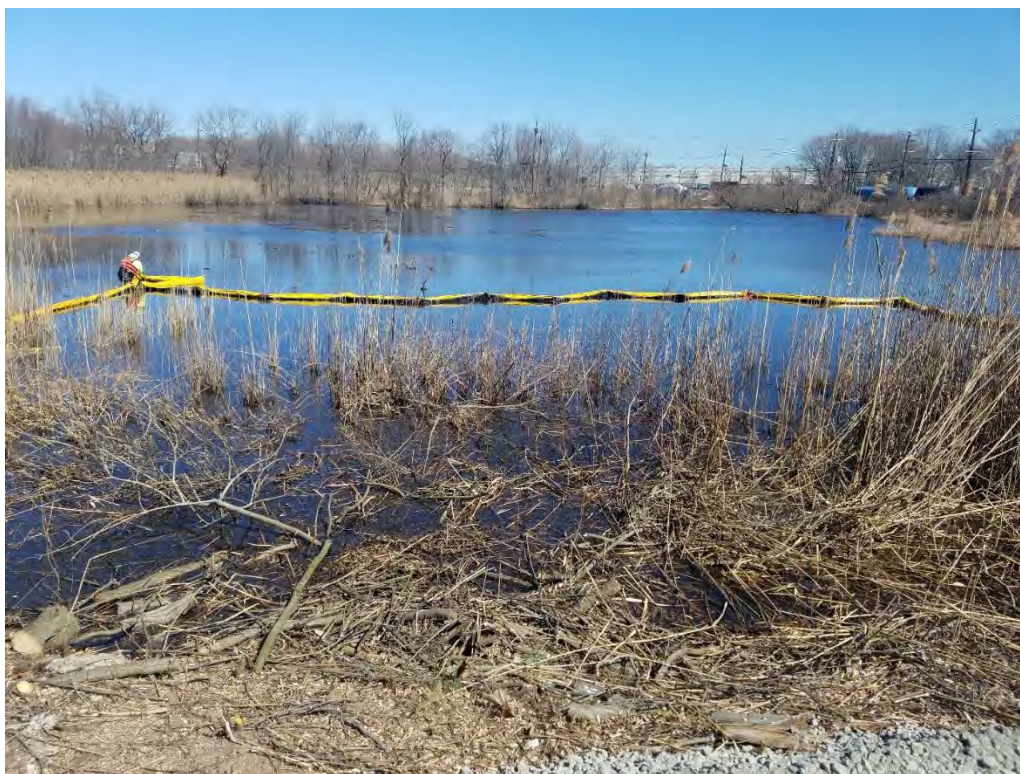
March 26, 2019. Deployment of turbidity curtain for construction of temporary staging and processing area.

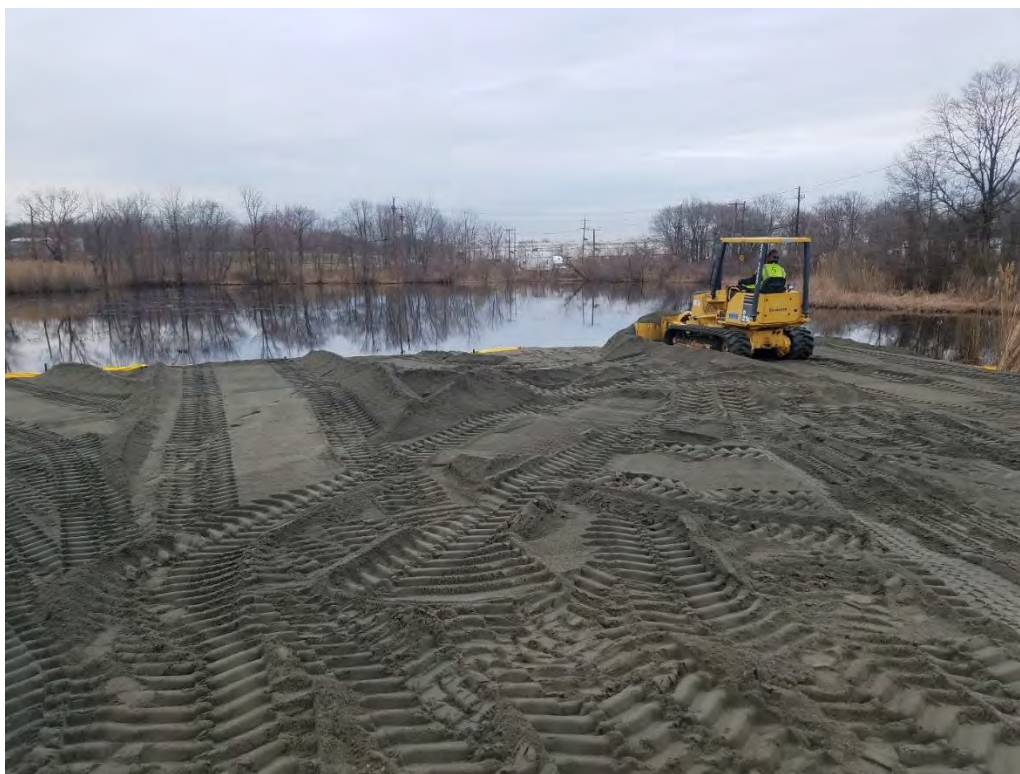
March 29, 2019. Placement of clean fill base for temporary staging and processing area

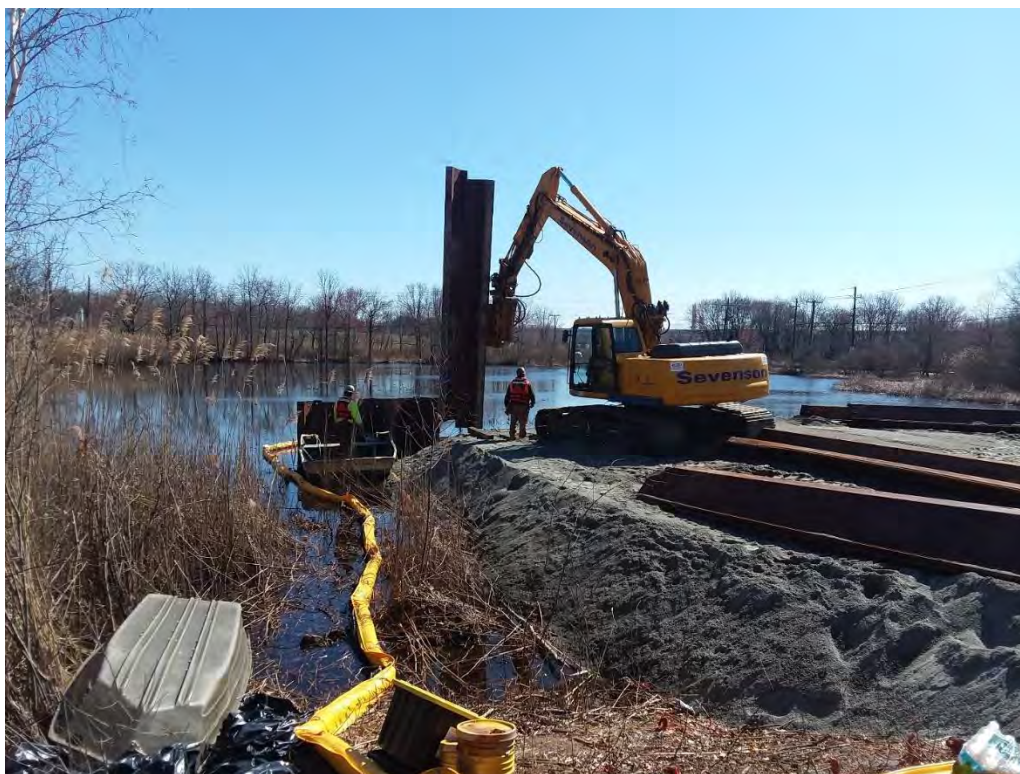
April 1, 2019. Installation of sheet piling bulkhead for temporary staging and processing area

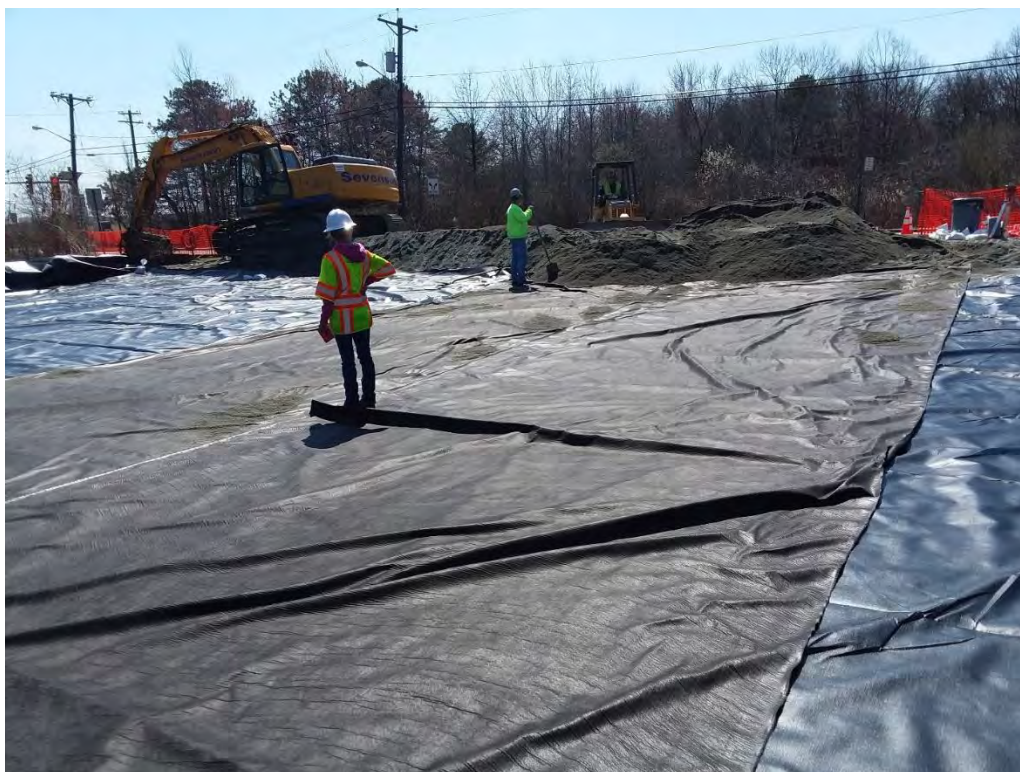
April 4, 2019. Placement of geotextile and protective liner in staging and processing area

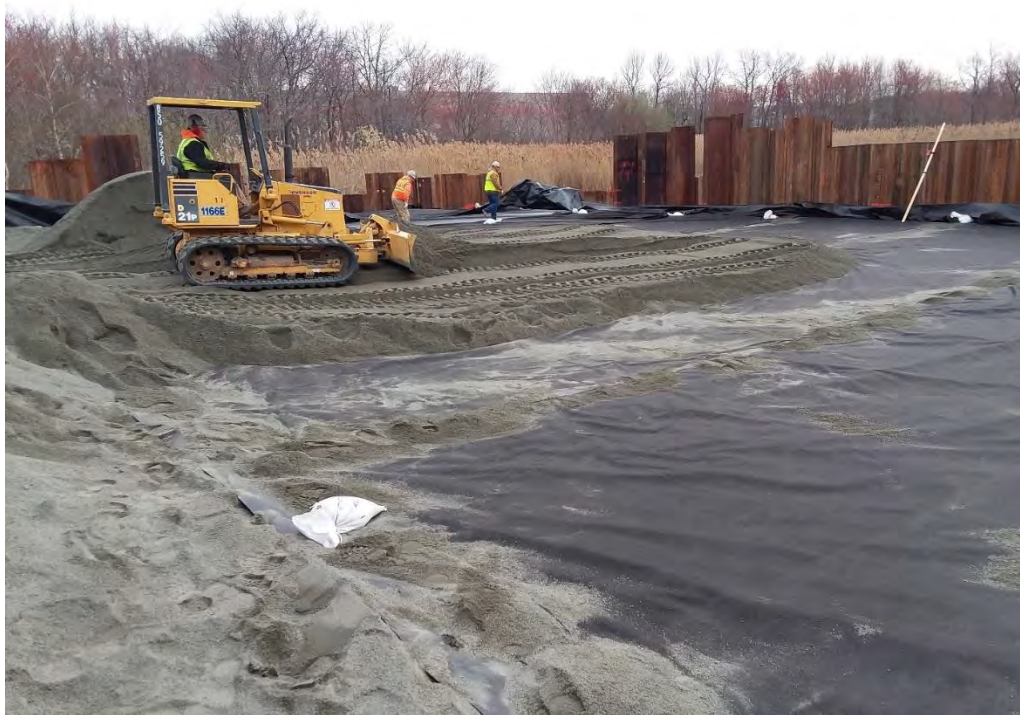
April 5, 2019. Placement of sacrificial fill material for working surface in staging and processing area.

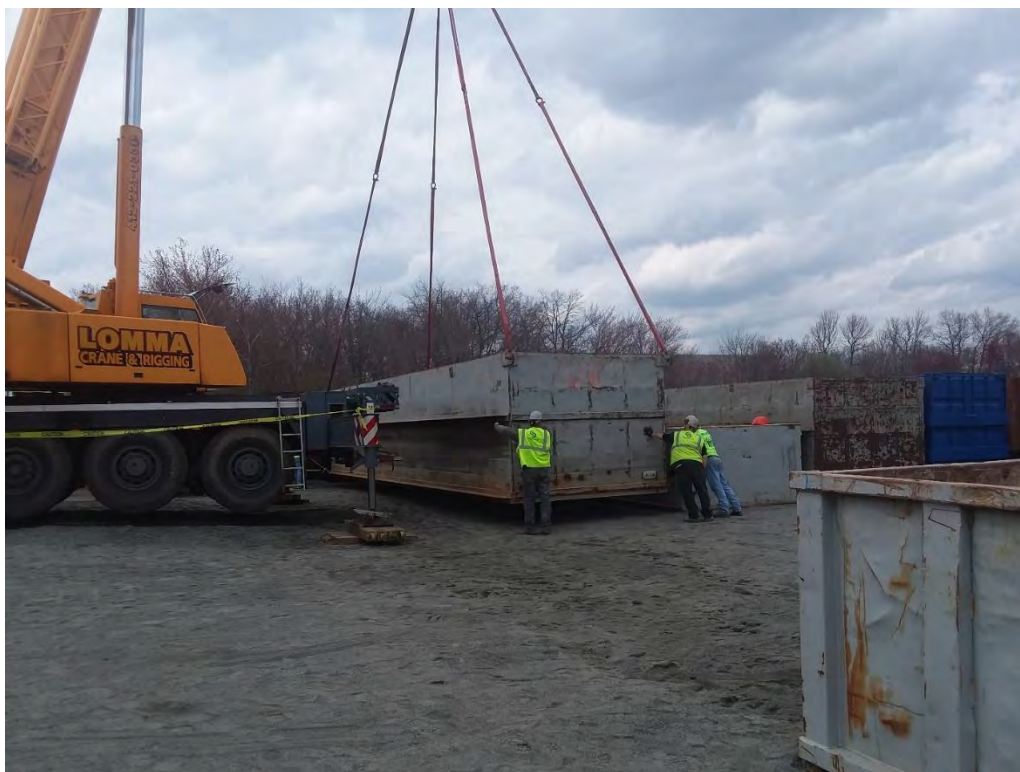
April 8, 2019. Placement of steel bins to be used for sediment stabilization.

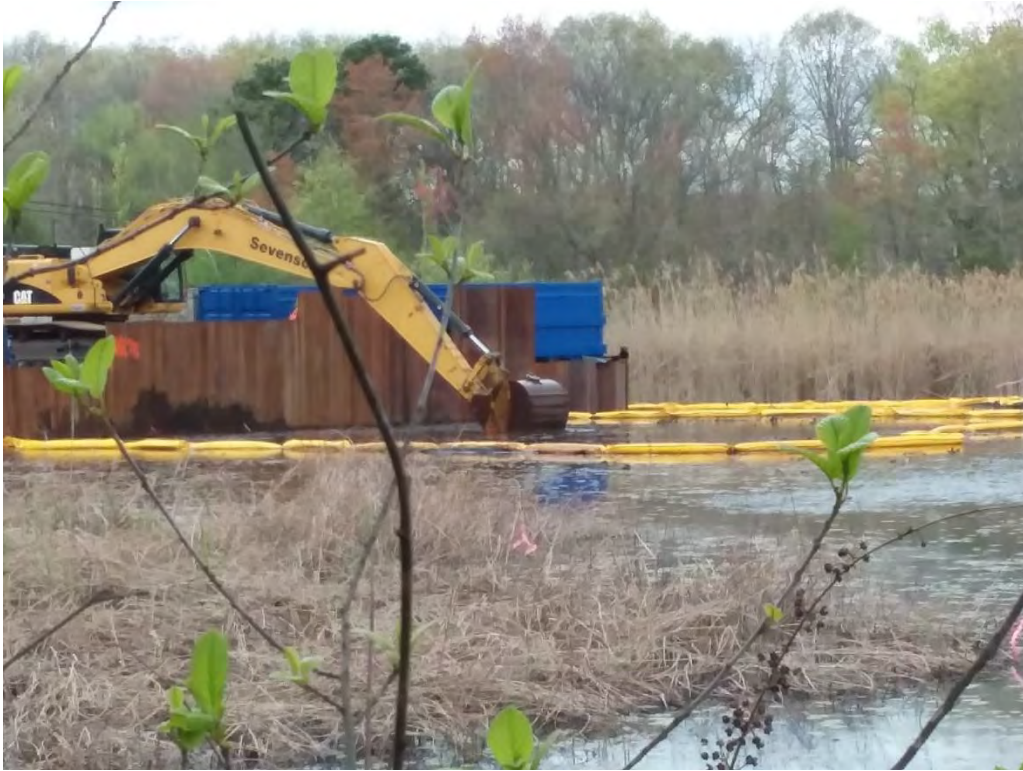
April 22, 2019. Excavation of access channel adjacent to temporary staging and processing area bulkhead.

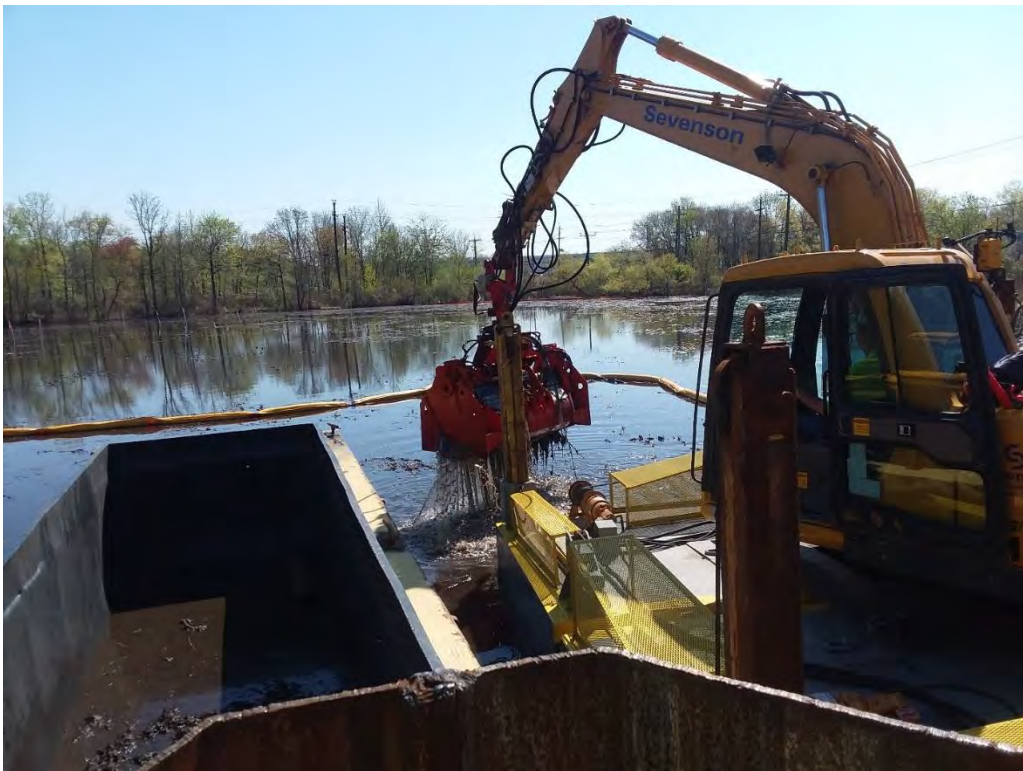
April 23, 2019. Dredging access channel.

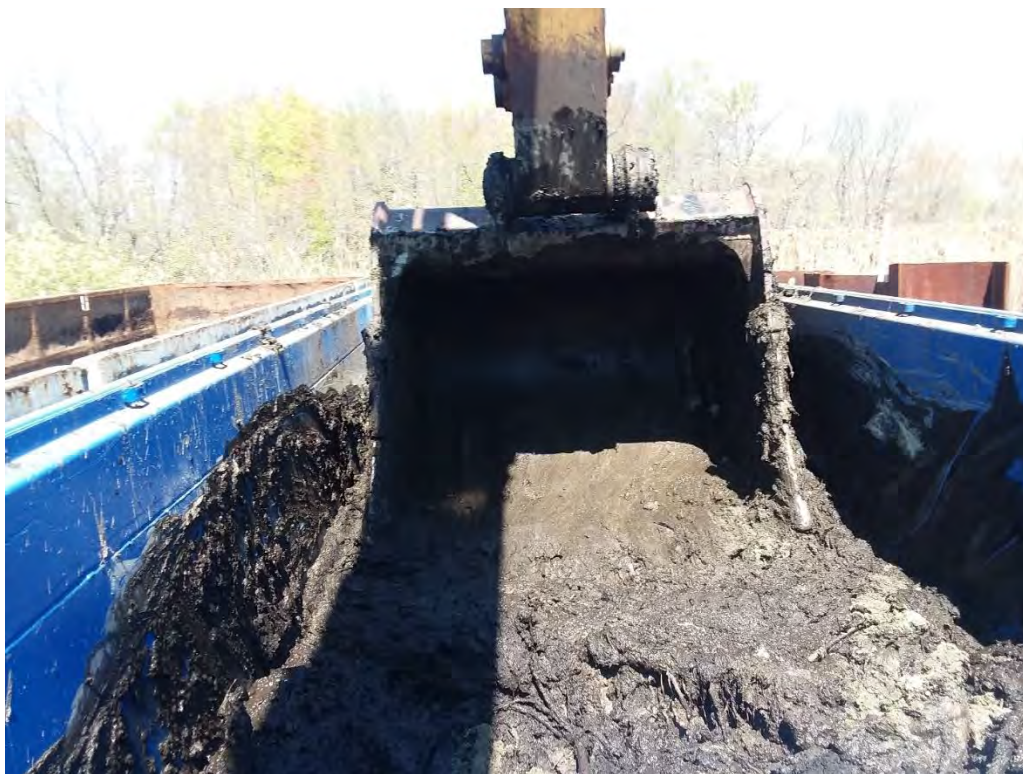
April 23, 2019. Stabilization of dredged sediments in steel hopper by mixing with Portland cement
